**Appendix B**  
**Photograph Log**

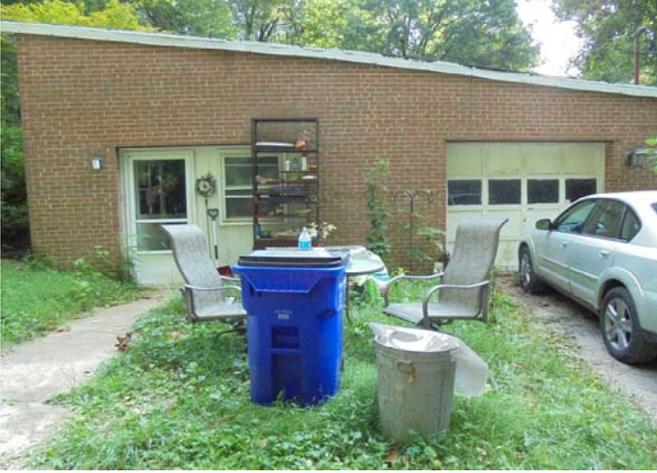
Photo 1. Tansill Residence on Parcel 349.

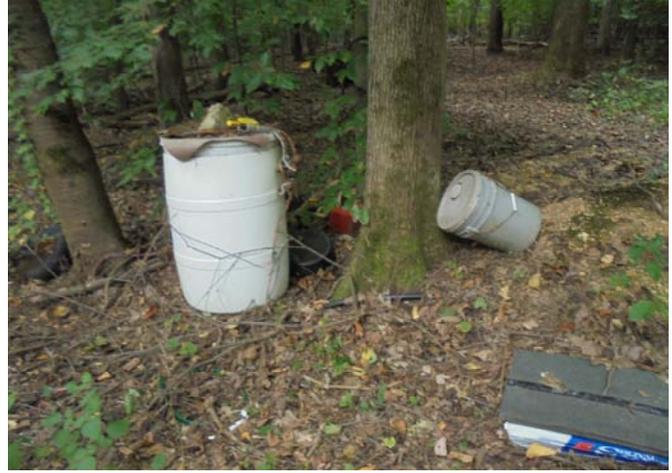
Photo 4. Partially filled 55-gallon plastic drum containing used oil.

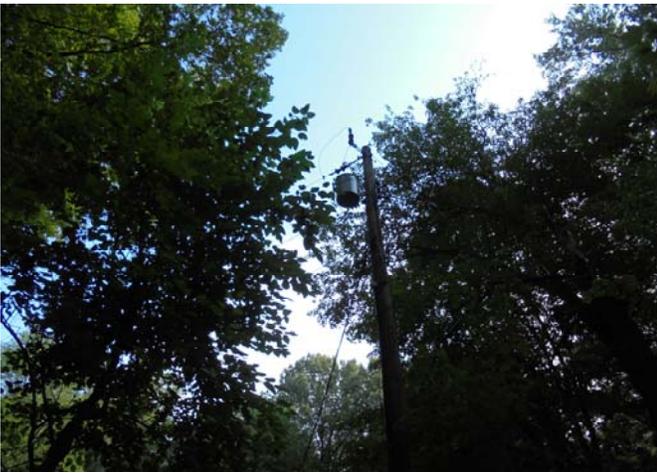
Photo 2. Pole mounted transformer observed on Parcel 349; Non-PCB blue placard observed.

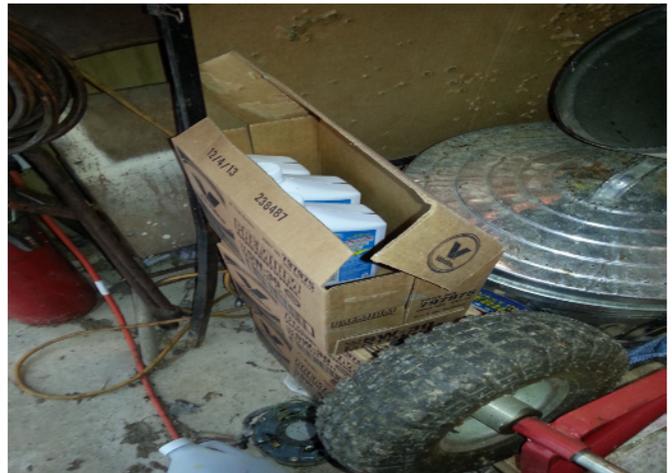
Photo 5. Stored new petroleum products observed in shed west of Tansill Residence on Parcel 349.

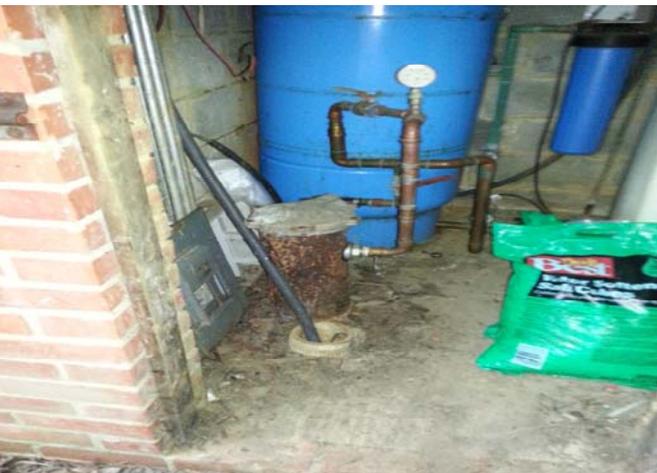
Photo 3. Private well associated with Parcel 349, located within a small well house.

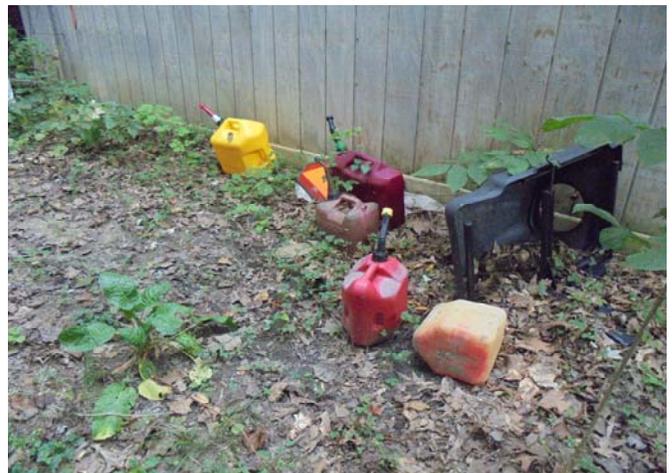
Photo 6. Plastic gasoline containers (< 5-gallons) observed near the exterior perimeter of the outbuildings on Parcel 349.

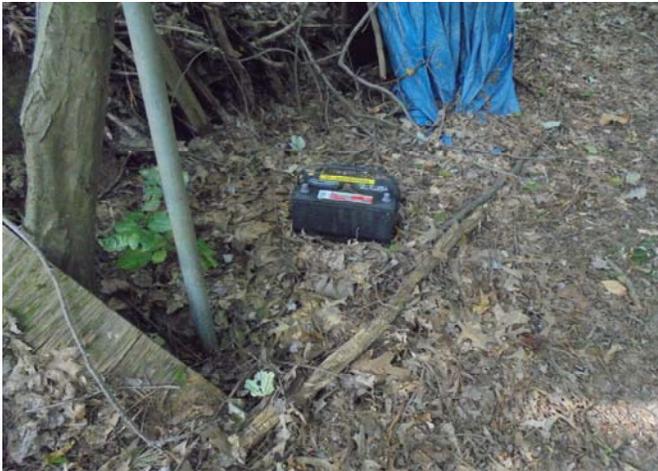
**Photo 7.** Lead-acid battery observed on ground surface on Parcel 349.

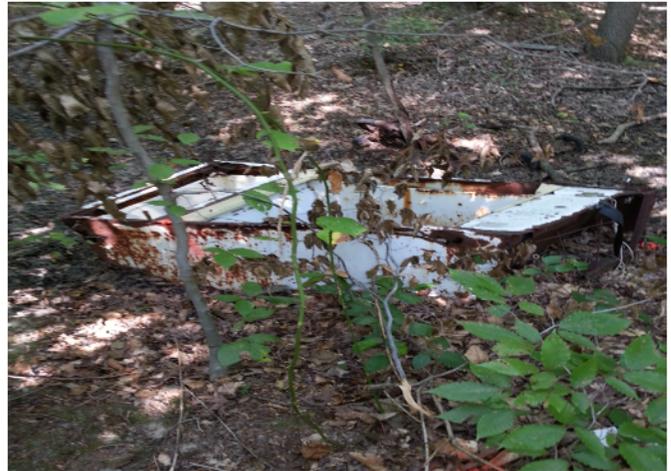
**Photo 10.** Discarded refrigerator observed at western property boundary of Parcel 235.

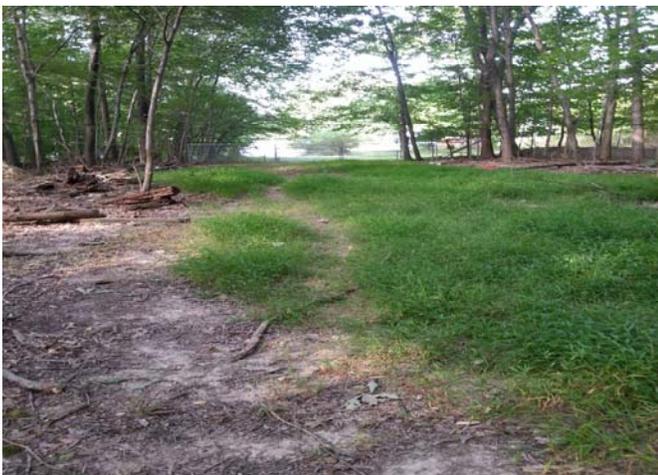
**Photo 8.** Sewer easement access looking west toward Rose Lane.

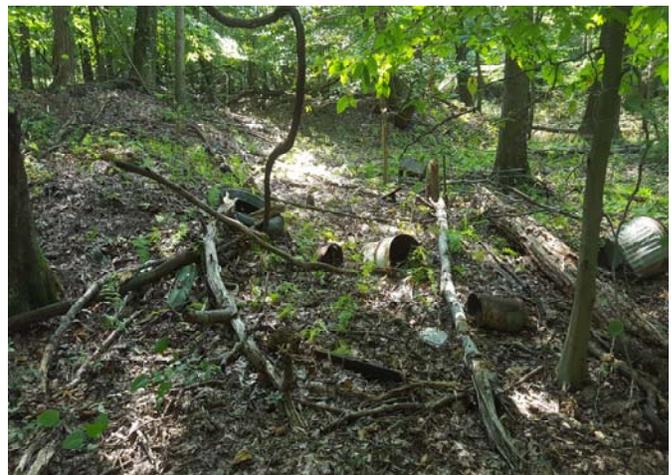
**Photo 11.** Example of area of mounded soil with associated automotive/non-household waste.

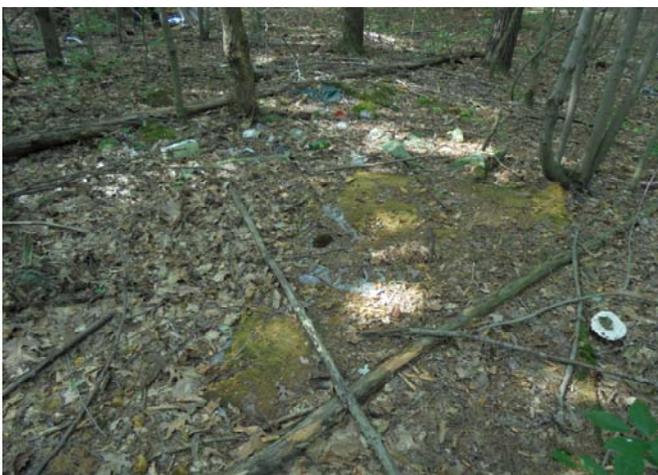
**Photo 9.** Example of discarded household waste observed along sewer easement.

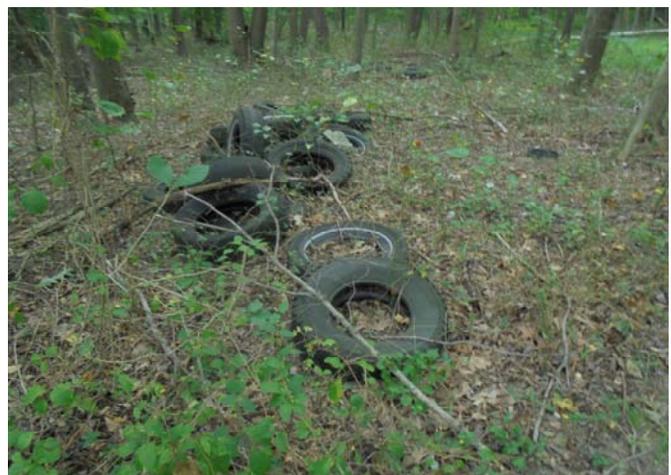
**Photo 12.** Discarded tires noted in multiple locations throughout the study area.

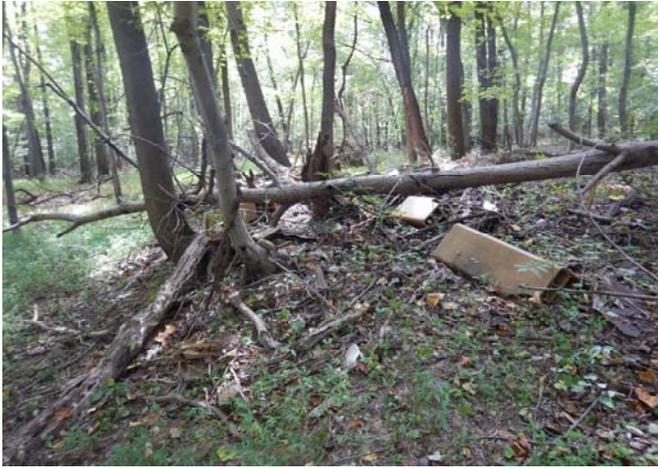
**Photo 13.** Large pile of waste with electrical construction materials observed on Parcel 235.

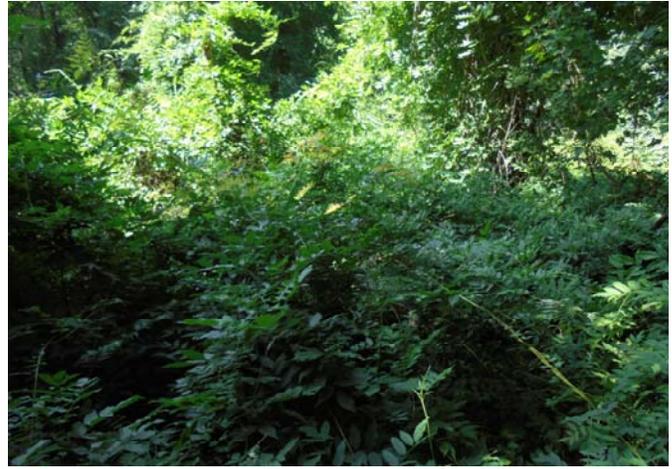
**Photo 16.** Heavily overgrown vegetation in the vicinity of the former dwelling on Parcel 235.

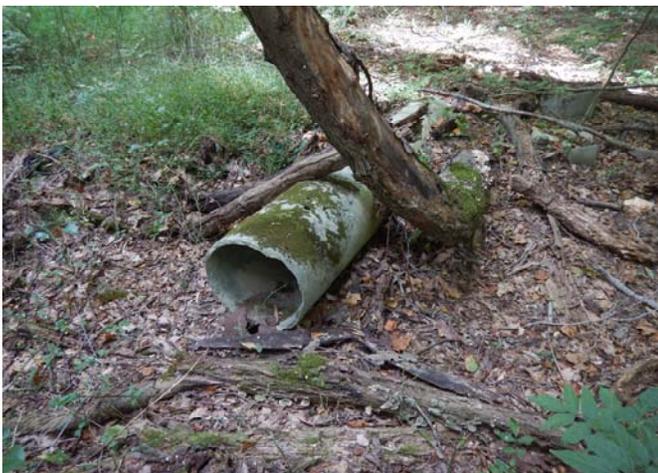
**Photo 14.** Representative transite pipe observed in multiple location onsite.

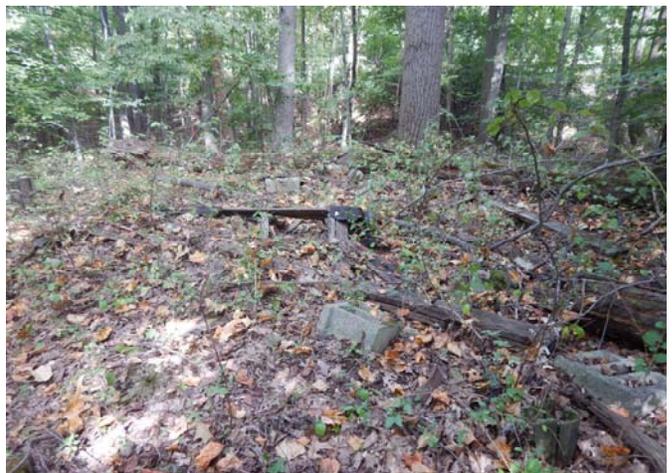
**Photo 17.** Remnant possible structure observed near northeastern boundary of Parcel 235.

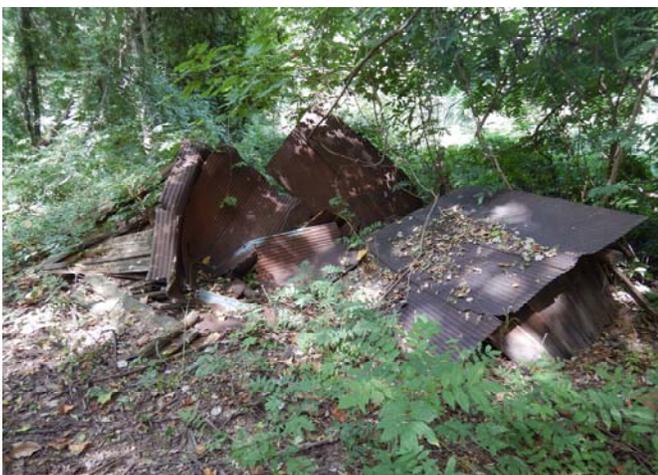
**Photo 15.** Collapsed small structure observed on Parcel 235 between Parcel 349 and the railroad tracks.

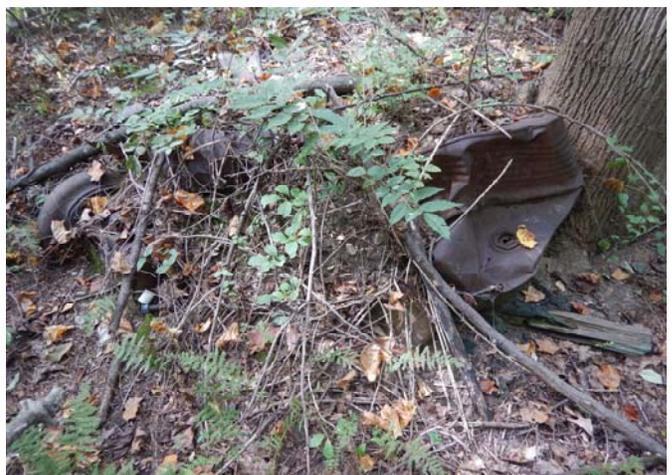
**Photo 18.** Typical metal debris observed on Parcel 235.

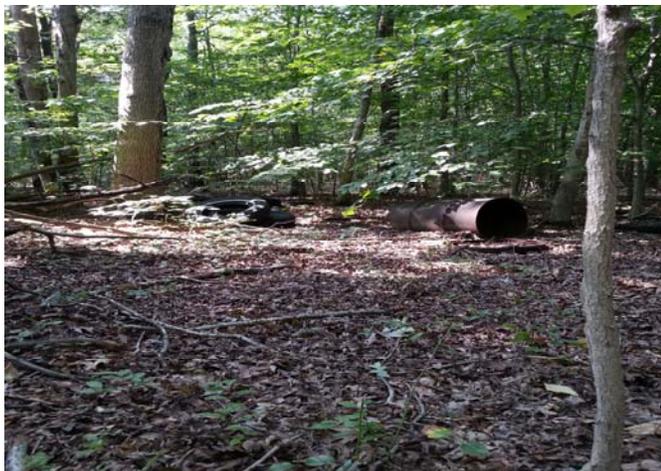
Photo 19. Area to the west of Parcel 235 observed with approximately 20 tires.

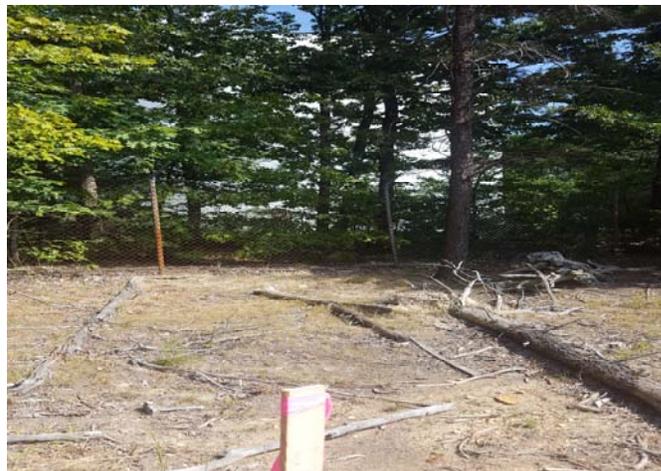
Photo 22. Looking southeast towards water tower adjacent to the south of Parcel 384.

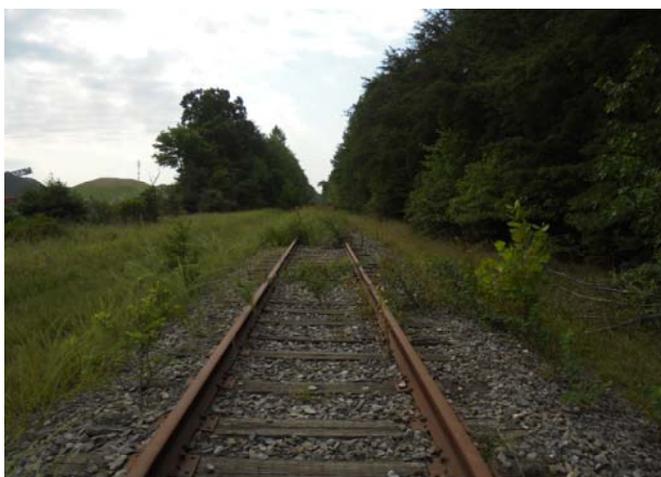
Photo 20. Out of service, railroad track that form the eastern boundary of the study area. Note Savage Stone quarry on left, looking south.

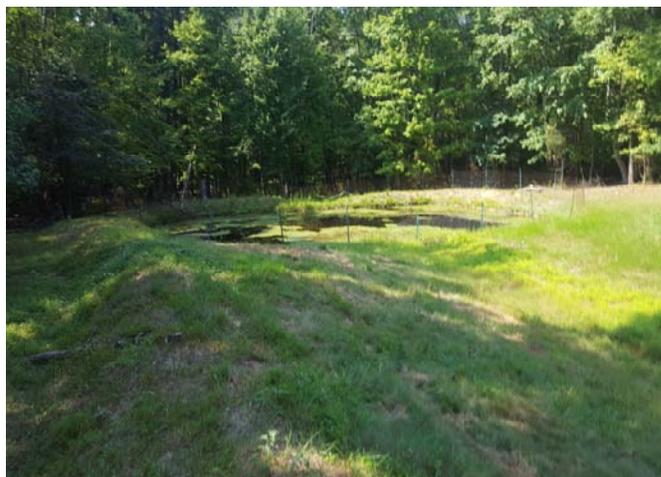
Photo 23. Stormwater retention pond observed in the southeast corner of Parcel 235, associated with the former Laurel Lumber reclaimed mine located southwest of Parcel 235.

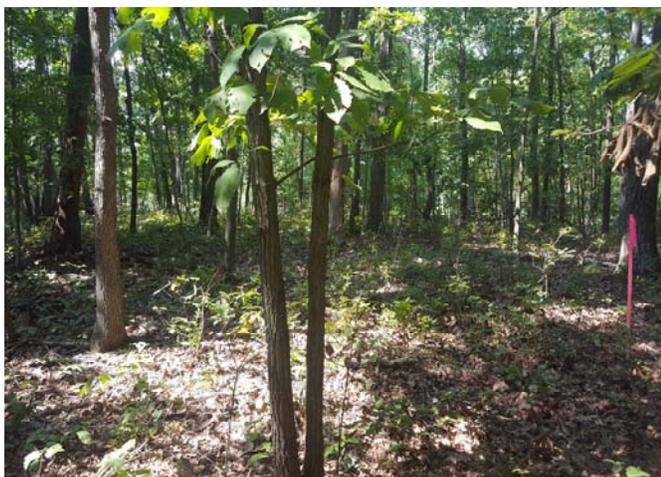
Photo 21. Typical open wooded land of Parcel 384.

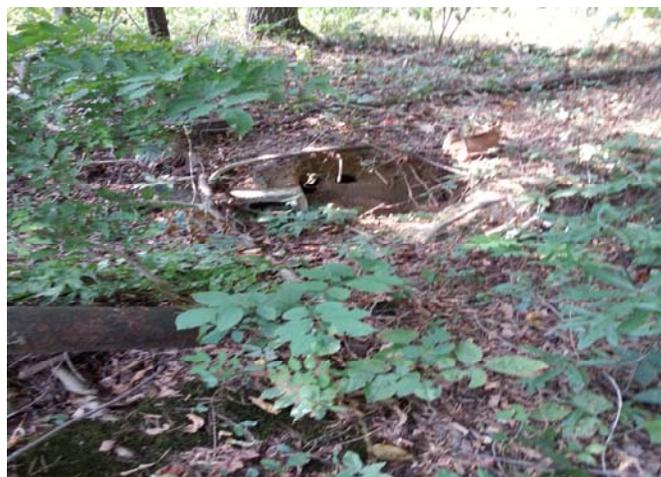
Photo 24. Possible building remnants/piping observed near the northern boundary of Parcel B.
